Manhole Inspection Summary

Manhole # S03CC2023MH

Location Address: **6120 BENHURST RD**

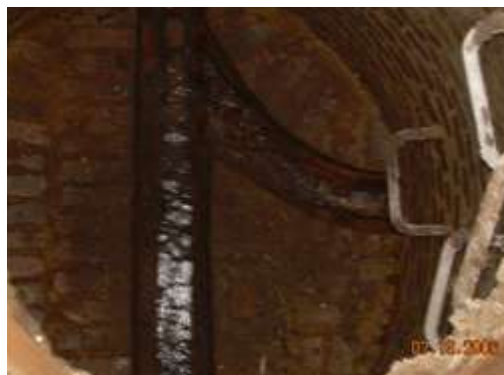
Top View

Adjustment and Corbel infiltration. Bench debris.

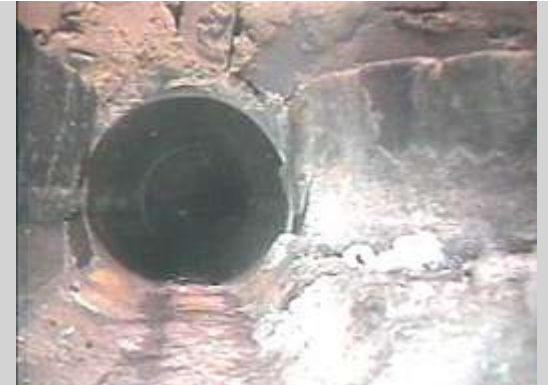
8 in. Circular Gravity Sewer Pipe Out @ 12 O'Clock

Comments **The O12 pipe picture shows Barrel deterioration and infiltration. It also shows grease deposits in the Channel. The I3 pipe seal is not flush to the pipe.**

Infiltration: **Evidence** Pipe Seal Cond: **Cracked**

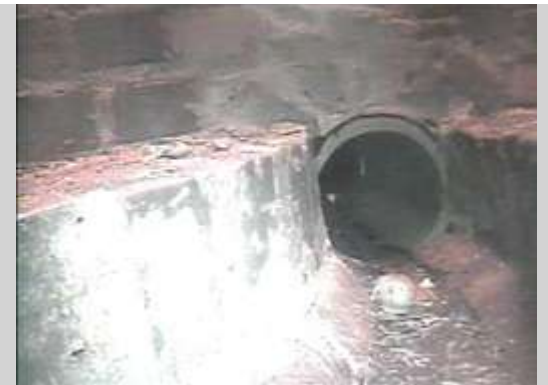
6 in. Circular Gravity Sewer Pipe In @ 3 O'Clock

Infiltration: **Evidence** Pipe Seal Cond: **Unknown**

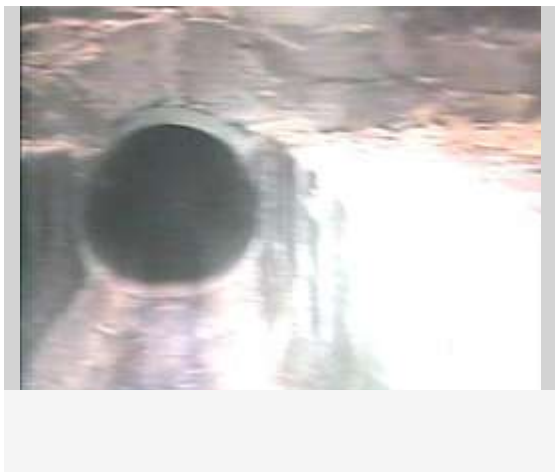
8 in. Circular Gravity Sewer
Pipe In @ 6 O'Clock

Infiltration: **Evidence** Pipe Seal Cond: **Unknown**
